Iowa Utilities Commission

# 2025 Pipeline Safety Conference

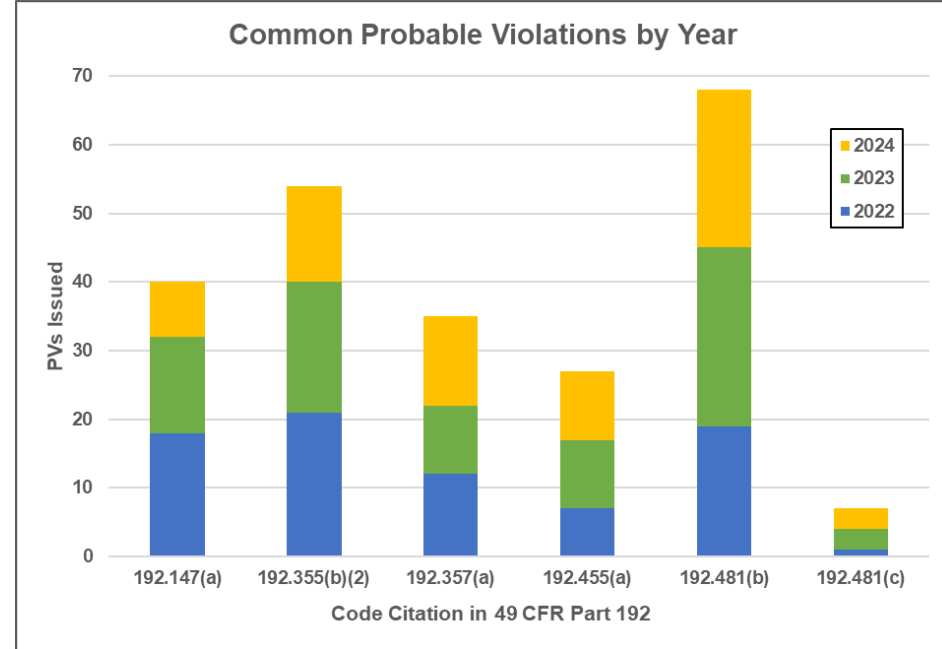
1. Introductions
2. Safety Moment
3. Preparation for Inspections
4. Common Probable Violations (PVs)
  - a. 49 CFR 192.147(a)
  - b. 49 CFR 192.355(b)(2)
  - c. 49 CFR 192.357(a)
  - d. 49 CFR 192.455(a)
  - e. 49 CFR 192.481(b)
  - f. 49 CFR 192.481(c)
5. Responses to Inspection Reports
6. Questions

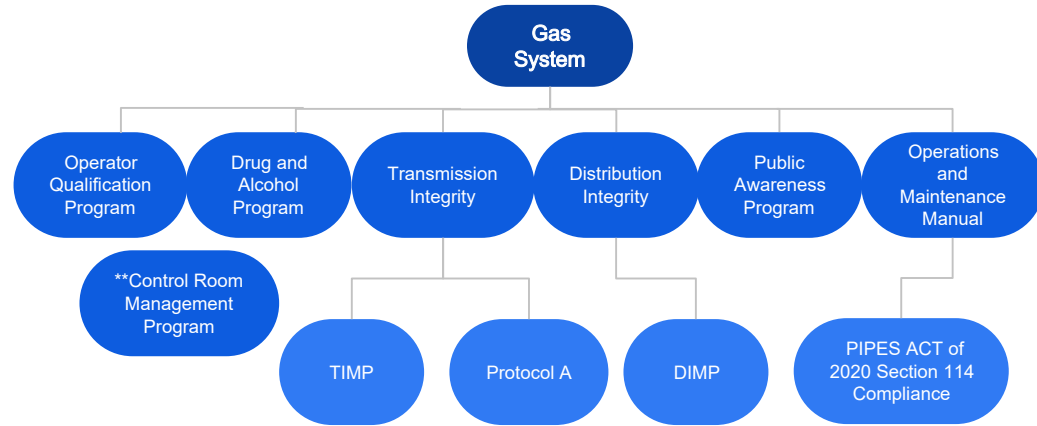
# Common Probable Violations (PVs)

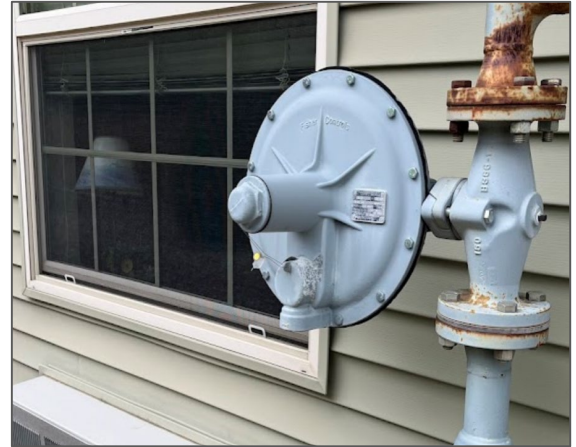
Example of vent near window

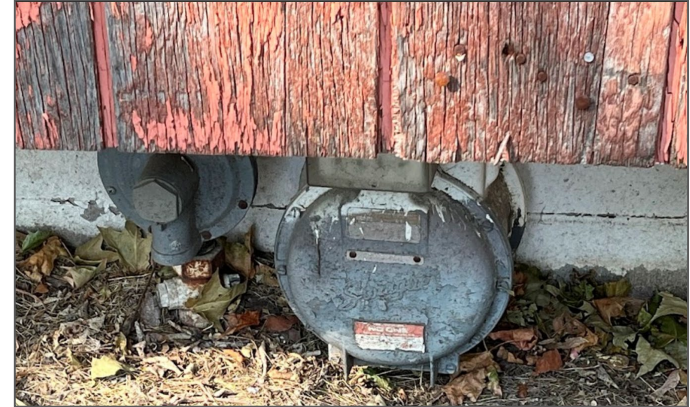
If this relief opens, can the gas vent freely to atmosphere?

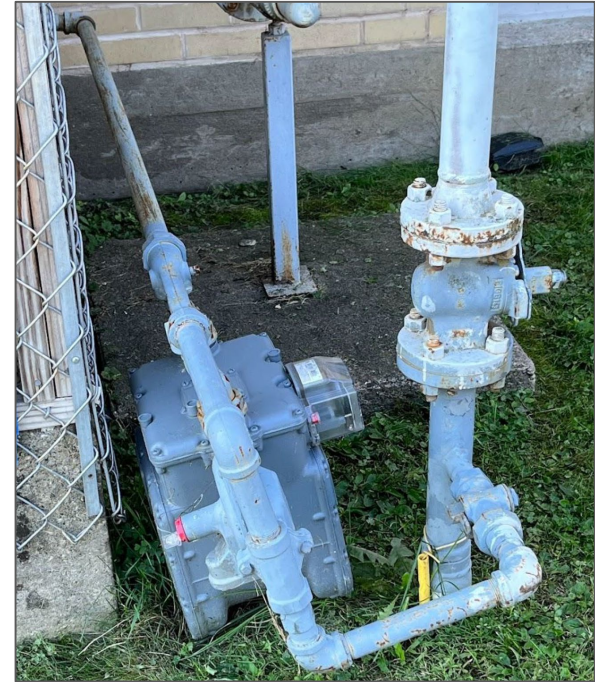
Example of stressed meter piping

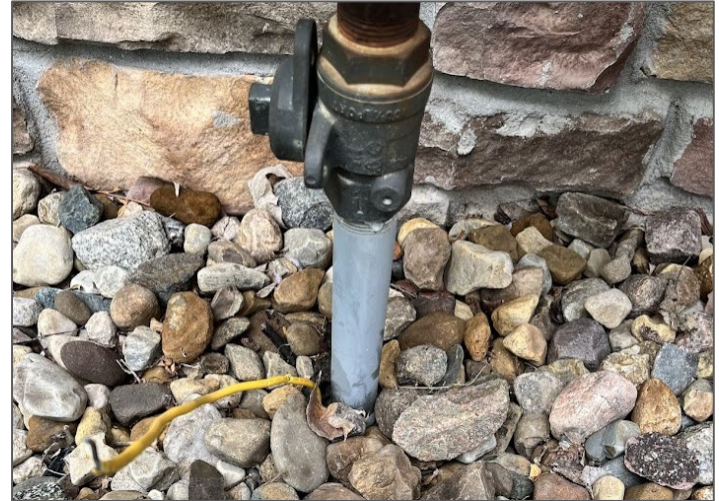
Example of buried anodeless riser crimp identified in 2024 inspection

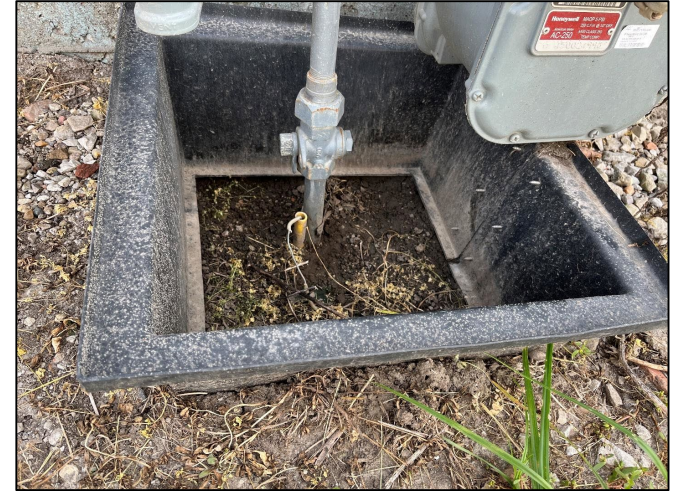
Example of buried crimp identified in 2024 inspection

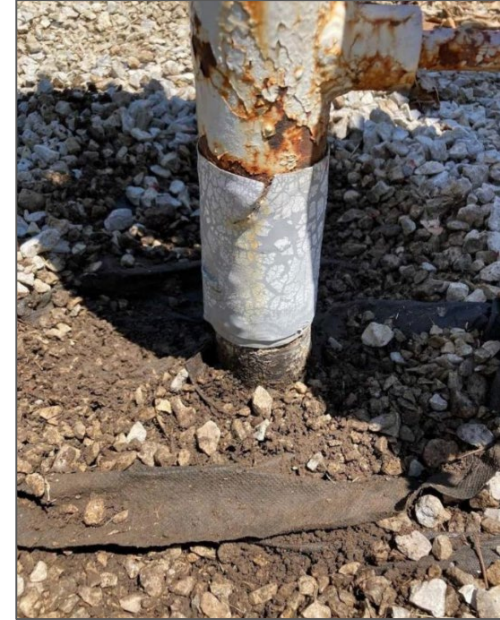
Example of damaged wrap at soil-to-air interface

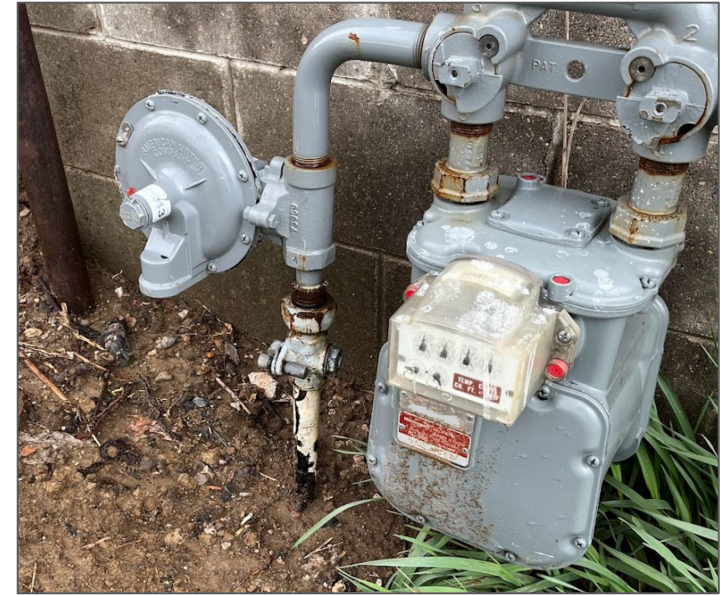
Example of damaged coating identified in 2024 inspection

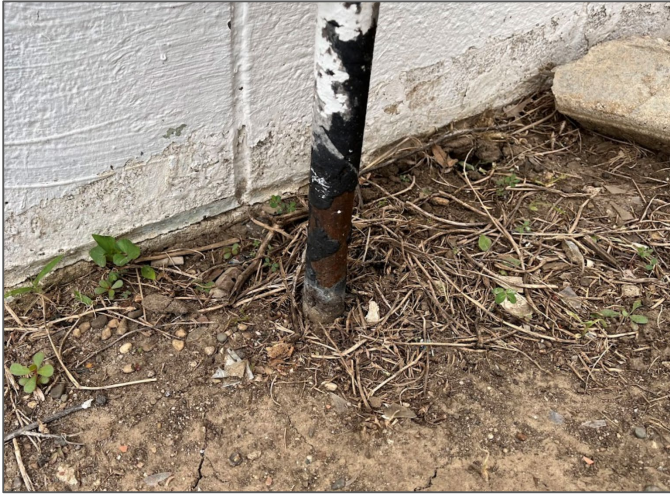
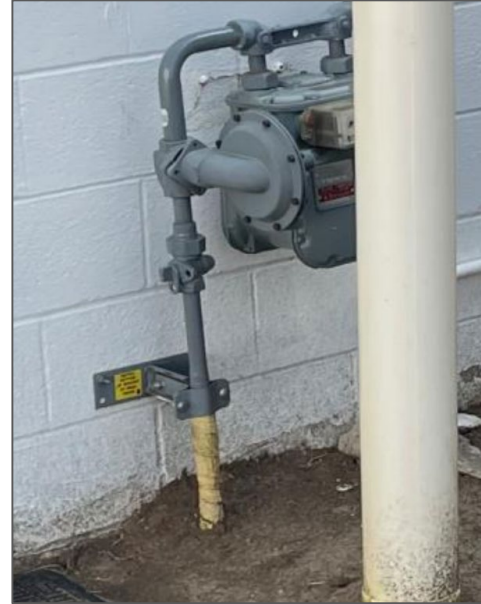
# Common PV - 49 CFR 192.481(b)

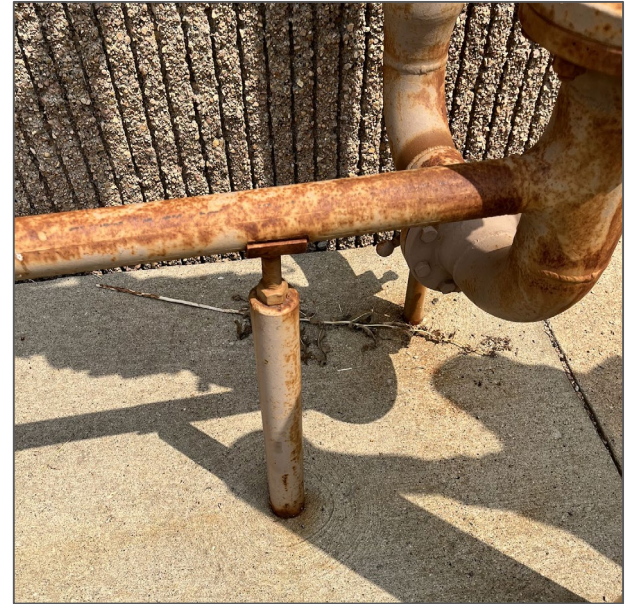
Example of Pipe Support

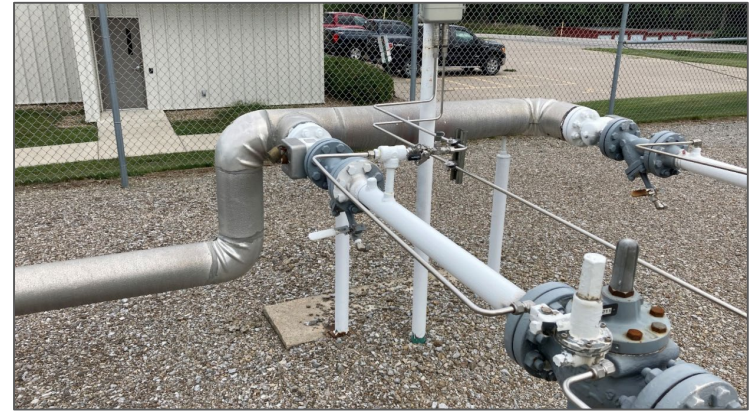
Inspect Under Insulation

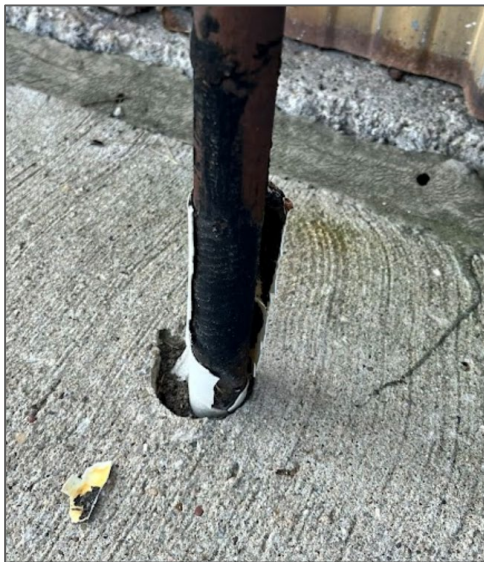
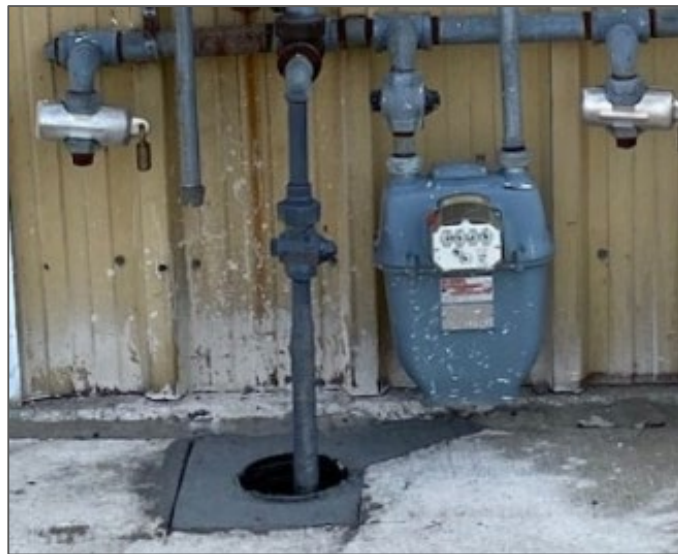
# Common PV - 49 CFR 192.481(c)

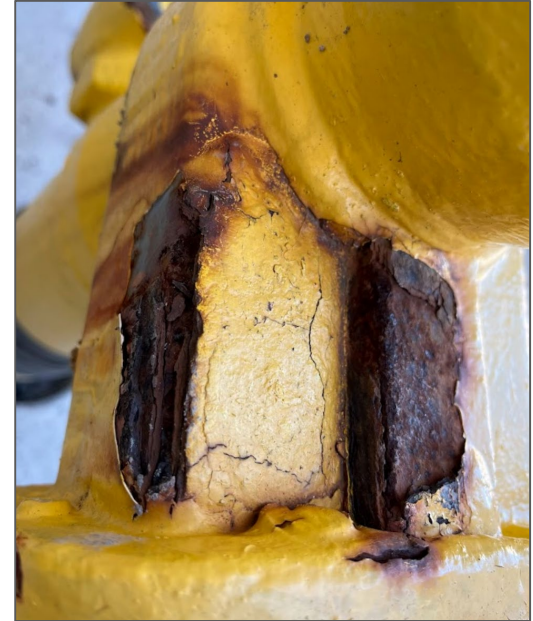
Metal Loss on Service Valve

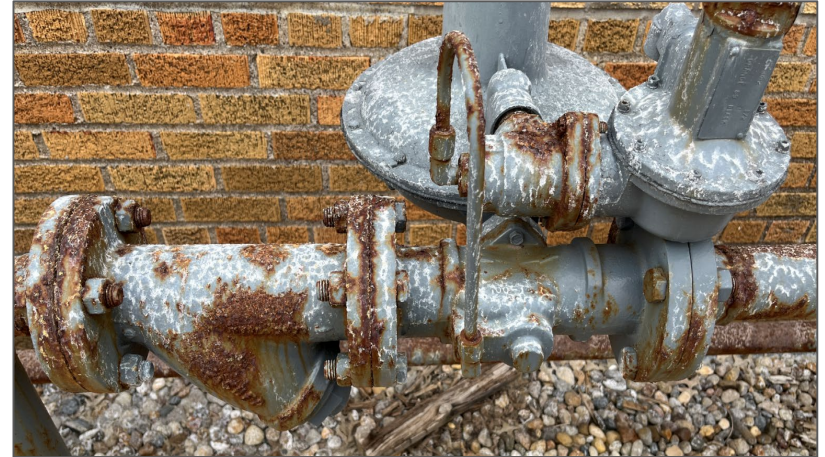
Example of atmospheric corrosion at meter set

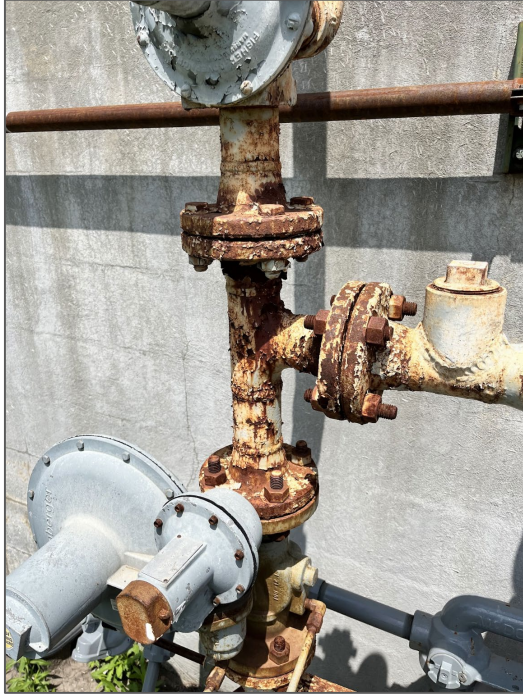
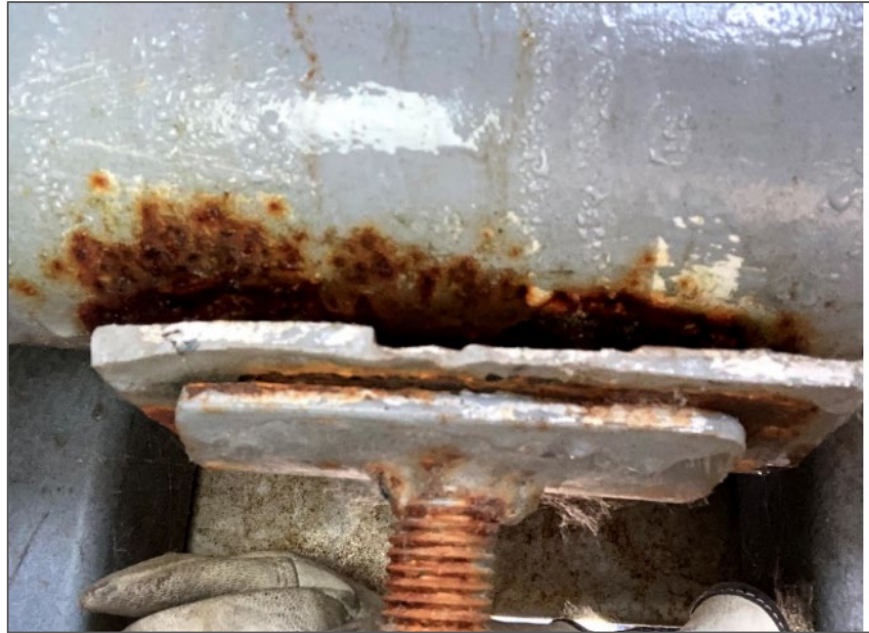
# Common PV - 49 CFR 192.481(c)

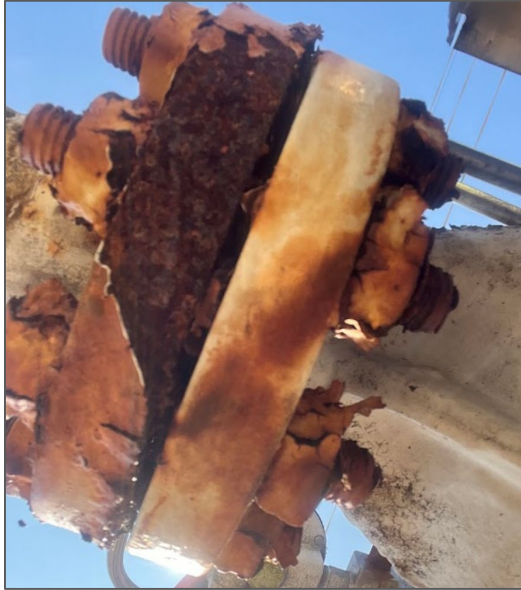
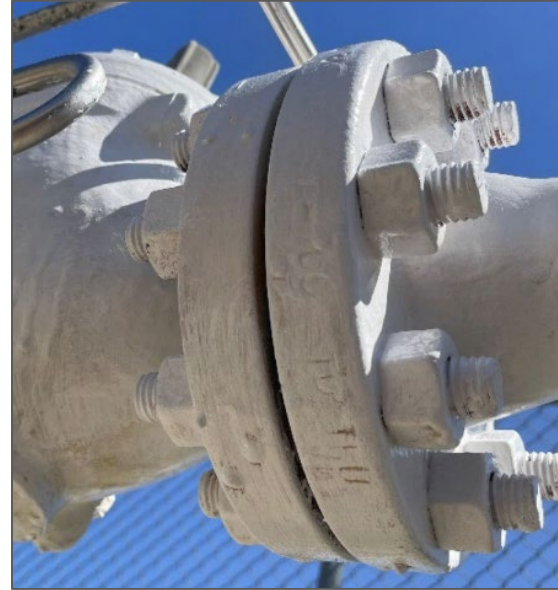
# Preventive Maintenance

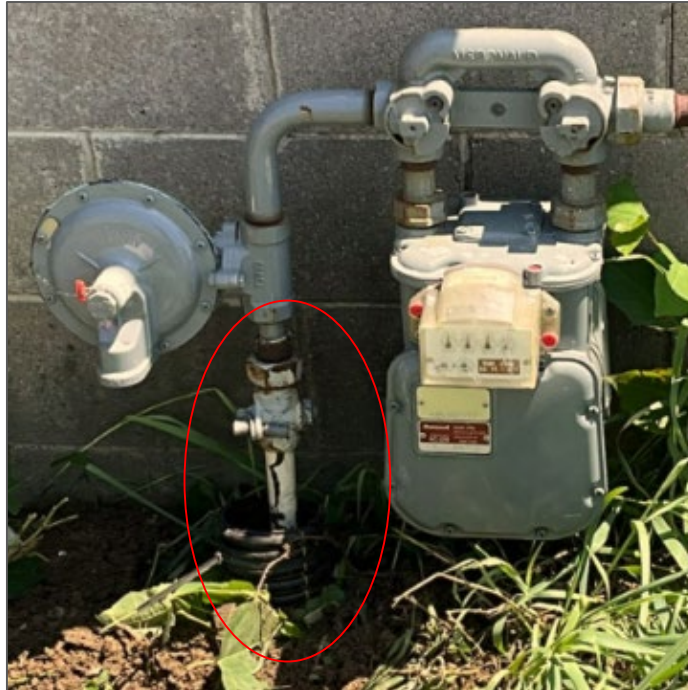
# Responses to Inspection Reports
